## Chapter 9

# FIRE BEHAVIOR IN WORLD TRADE CENTER 2

### 9.1 INTRODUCTION

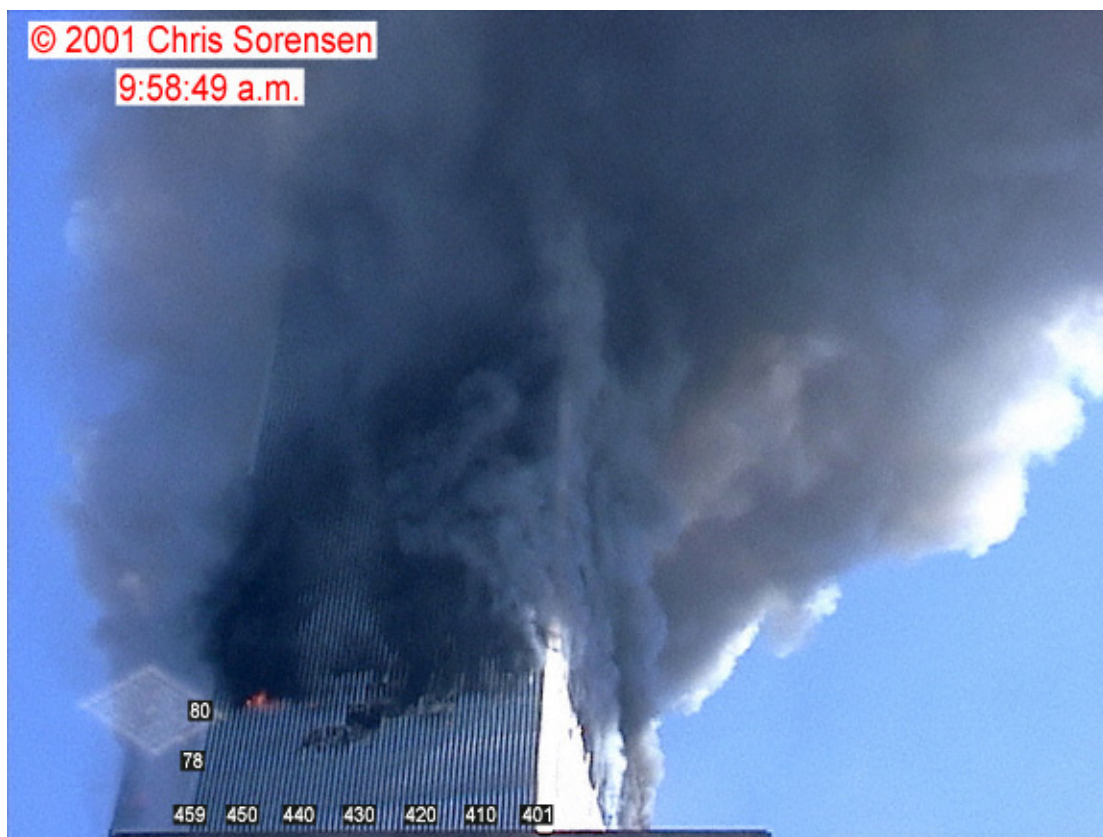
A view of the south face of WTC 2 captured from a video at 9:58:49 a.m. is shown in Figure 9–87. It was taken just 10 s before the start of the collapse of the tower. Flames are visible on the 80th floor from windows 80-440 to 80-452, and smoke is flowing from open windows 80-438 to 80-455. The aerial video shows that the bright region of flame near window 80-450 flared up briefly for several seconds around this time. There are no distinct flames visible at other locations on the face. In particular, the flames visible inside the aircraft impact cavity in Figure 9–86 are not seen from this angle.

**Figure 9-87. This image of the south face of WTC 2 is a frame captured from a video recorded at 9:58:49 a.m. The intensity levels have been adjusted, and column and floor numbers have been added.**

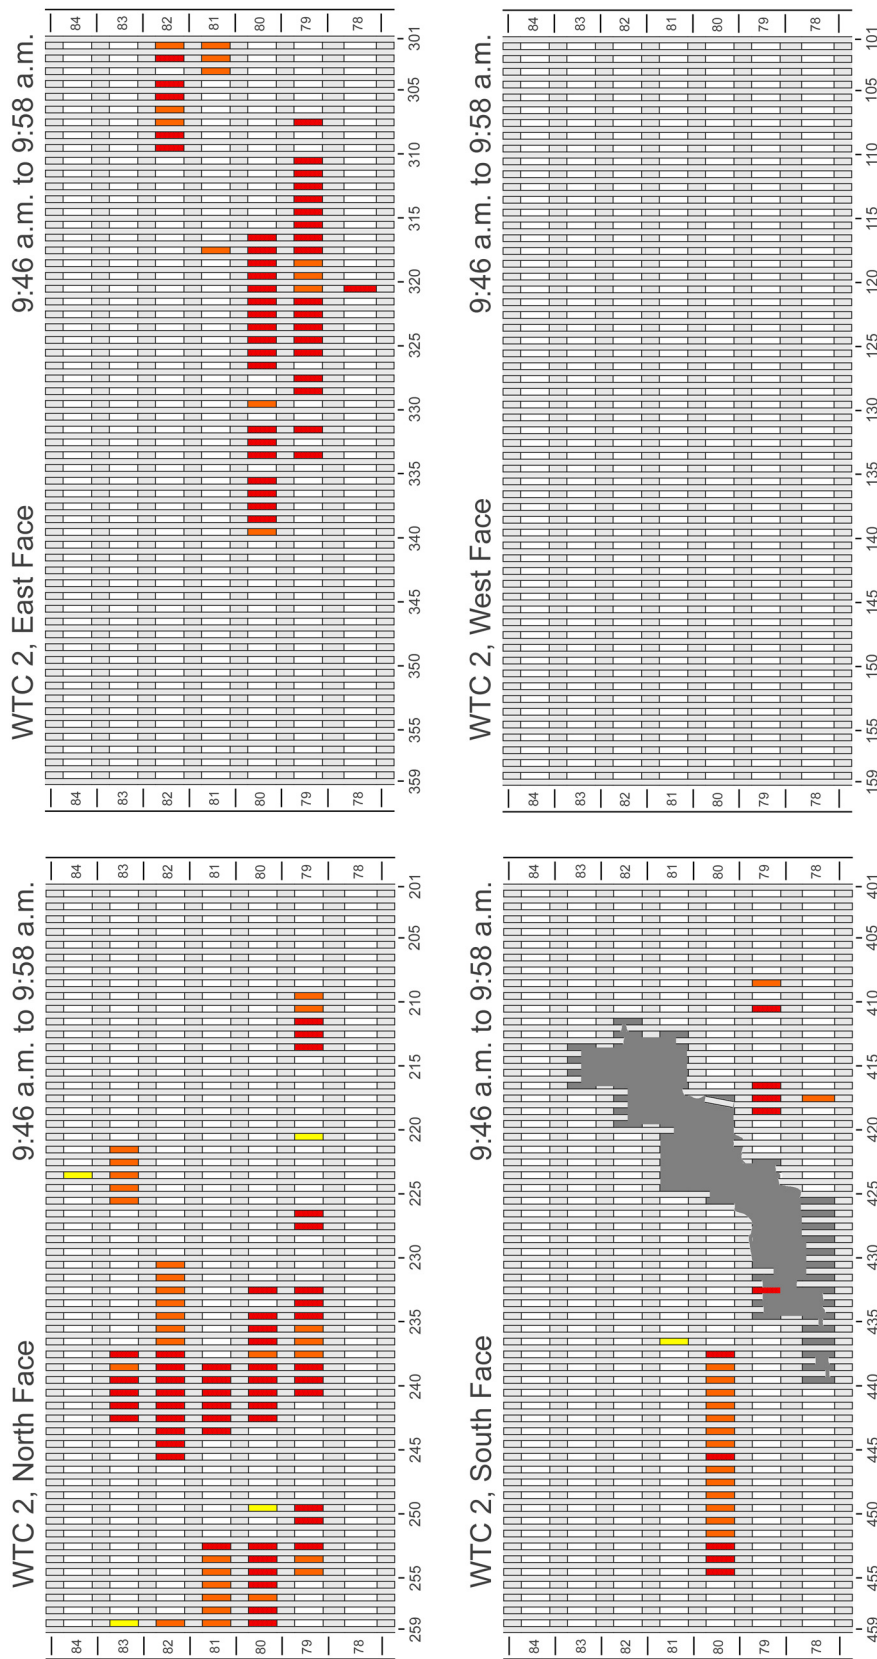
Façade maps of integrated fire intensities for the period from 9:45 a.m. to 9:59 a.m. are shown in Figure 9-88. Comparison with the corresponding maps for the 9:29 a.m. to 9:45 a.m. period shown in Figure 9-60 is helpful for tracking the changes in fire distributions during the current period.

Many of the fires observed during earlier periods were either no longer visible or were dying down during the final interval prior to the tower collapse. Fires dying down included those burning on debris piles located in the northeast corner of the tower and near the center of the north face on the 79th floor, a fire that had earlier burned from south to north across the 82nd floor on the east face, and numerous small fires ignited around the aircraft impact cavity on the south face.

At the same time, fires spread to areas of the faces that had not been involved earlier, including the north face toward the west on the 79th, 82nd, and 83rd floors. There was also an indication that fire may have spread upward on the north face from the 83rd to the 84th floor. The fire growth and local spread on the 79th floor of the north face appeared to be rapid and took place at a location that was apparently removed from earlier fires. This may be an indication that fire spread to this area on the faces occurred from interior locations within the tower that were not visible from outside. The new areas of fire which appeared on both the 79th and 83rd floors developed rapidly and remained localized at a few windows. These behaviors suggest that these fires had spread into rooms with walls that terminated at nearby façade columns and limited further fire spread. On the 79th floor, flames were seen in window 79-209 to window 79-212. A floor plan layout for the 79th floor is shown in Figure B-10 in Appendix B. It indicates that a room was not present behind these windows. A room is indicated in the northwest corner with walls at columns 79-208 and 79-154. The fire on the 83rd floor appeared in windows 83-221 to 83-225. Unfortunately, a floor plan layout for this floor is not available for comparison. The visual evidence indicates that none of the spreading fires on the north face reached as far as the west face prior to the tower collapse.

**Figure 9-88. Maps of integrated fire observations between 9:45 a.m. and 9:59 a.m. are shown for the four faces of WTC 2. Colors represent the highest intensity fire observed in a window using the color scale defined in Figure 5-1.**

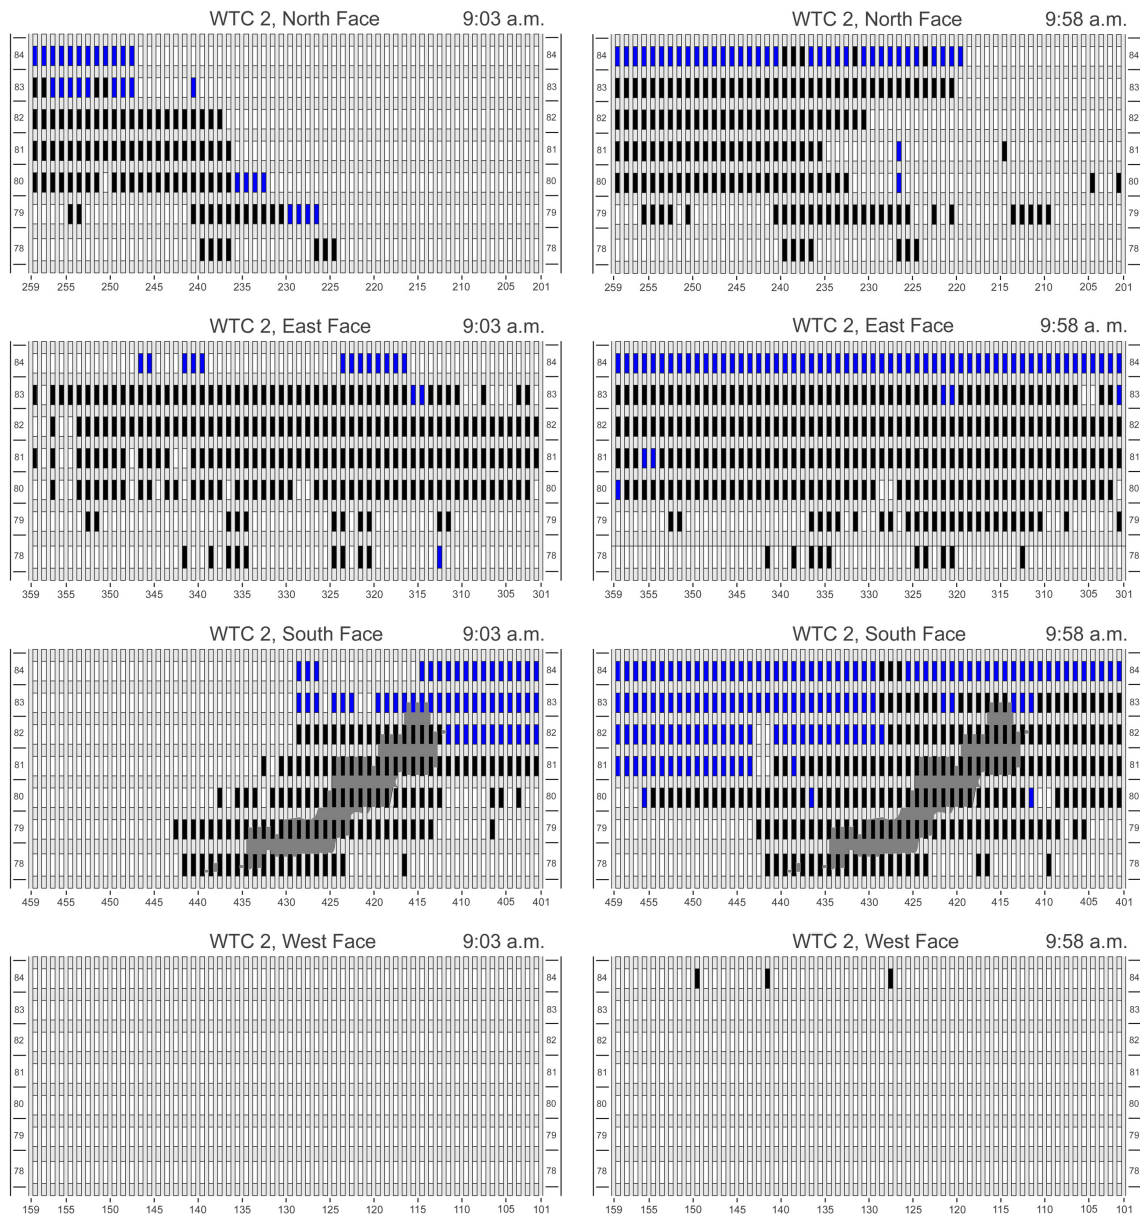
Similar to the analyses included in Chapter 8, changes in window condition can also be used as a rough indicator of fire spread. This analysis method has been used to complement the integrated fire data. The results are shown in Figure 9–91. It should be kept in mind that this approach only reveals fire spread that occurs to locations where windows were originally unopened. This is particularly important for WTC 2 because the number of windows opened by the aircraft impact and subsequent fireballs was much larger than for WTC 1. Even so, the analysis does provide a good estimate for fire spread into areas where window glass was still in place immediately following the aircraft impact.

**Figure 9-91. Maps for the 78th through the 84th floors compare missing window glass for the four faces of WTC 2 at two times, immediately following the aircraft impact at 9:02:59 a.m. and just prior to the collapse of WTC 1 at 9:58:59 a.m.**

On the north face significant fire spread took place on the 79th, 82nd, and 83rd floors. The effects of this fire spread are revealed by areas of fire (Figure 9–90) and opened windows (Figure 9–91) on the west sides of the areas of fire and open windows that were present shortly following the aircraft impact and fireballs. On the 79th floor this fire growth took place from the large fire burning on a pile of debris just to the east of the center of the face. Despite the presence of this sustained fire, westward fire spread on this floor was relatively slow and sporadic. The fire spread on the 82nd floor occurred just to the west of the cold spot (an area on the 80th, 81st, and 82nd floors between columns 238 and 250). Fire spread into this area was not observed until around 9:54 a.m. On the 83rd floor fire spread occurred in discrete segments that suggested fire was spreading across a series of rooms. The first large fire appeared just above the cold spot around 9:29 a.m. None of the fires that spread to the west on the north face appeared to reach the western edge of the tower by the time of collapse.

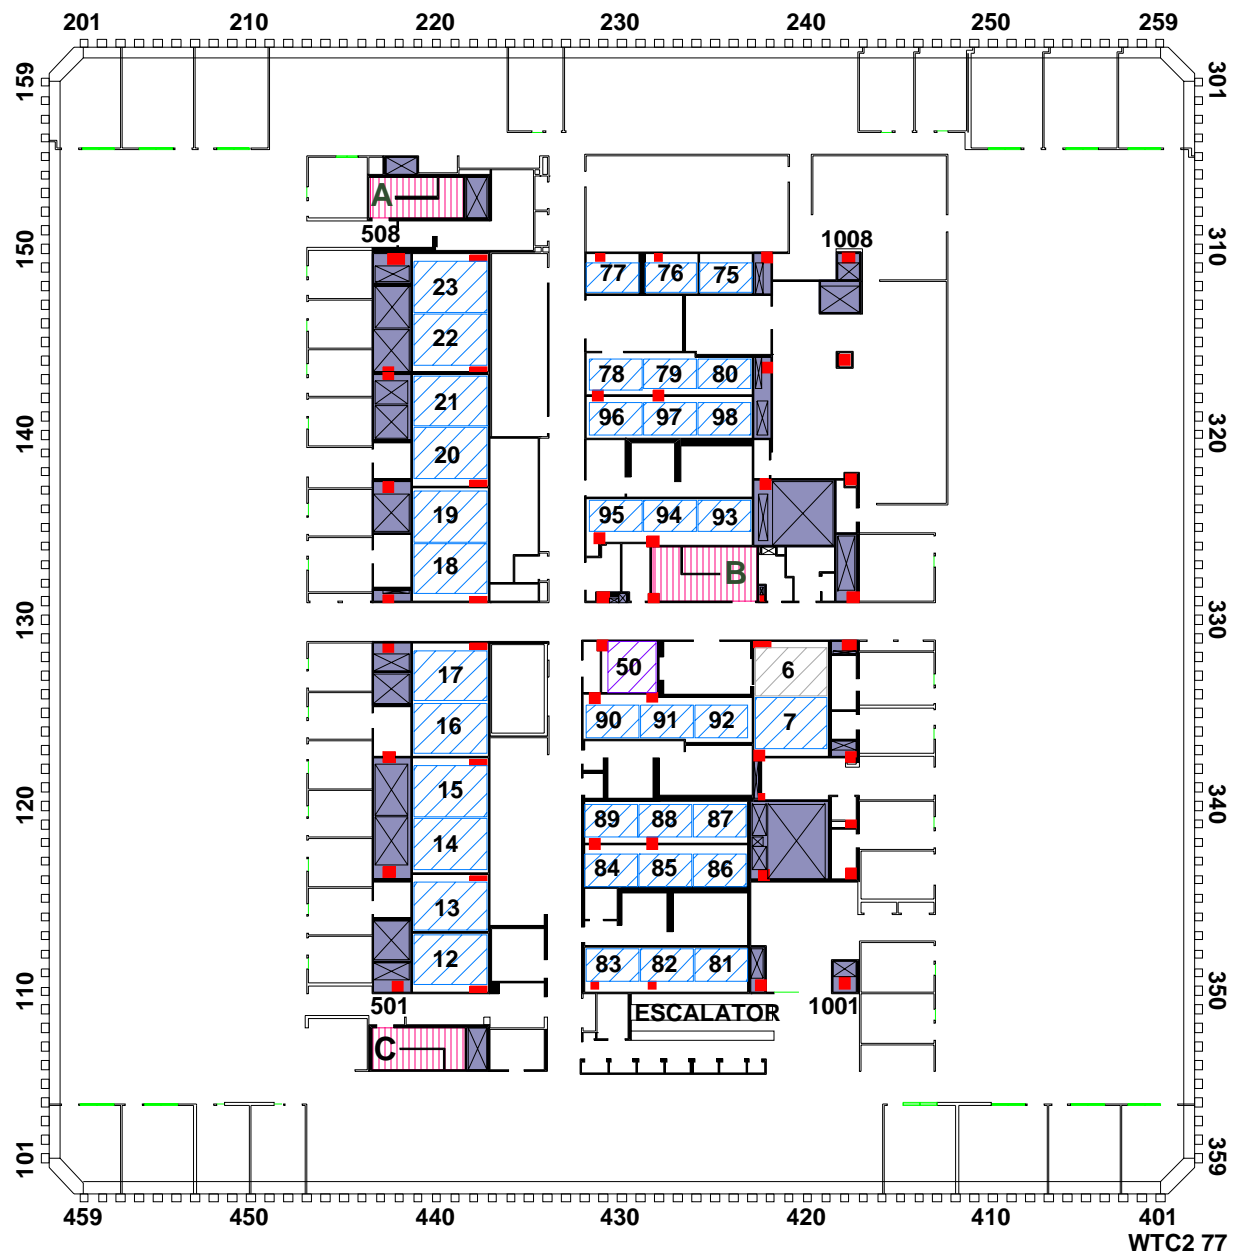
Figure B-9. This drawing shows the floor plan layout for the 77th floor of WTC 2.

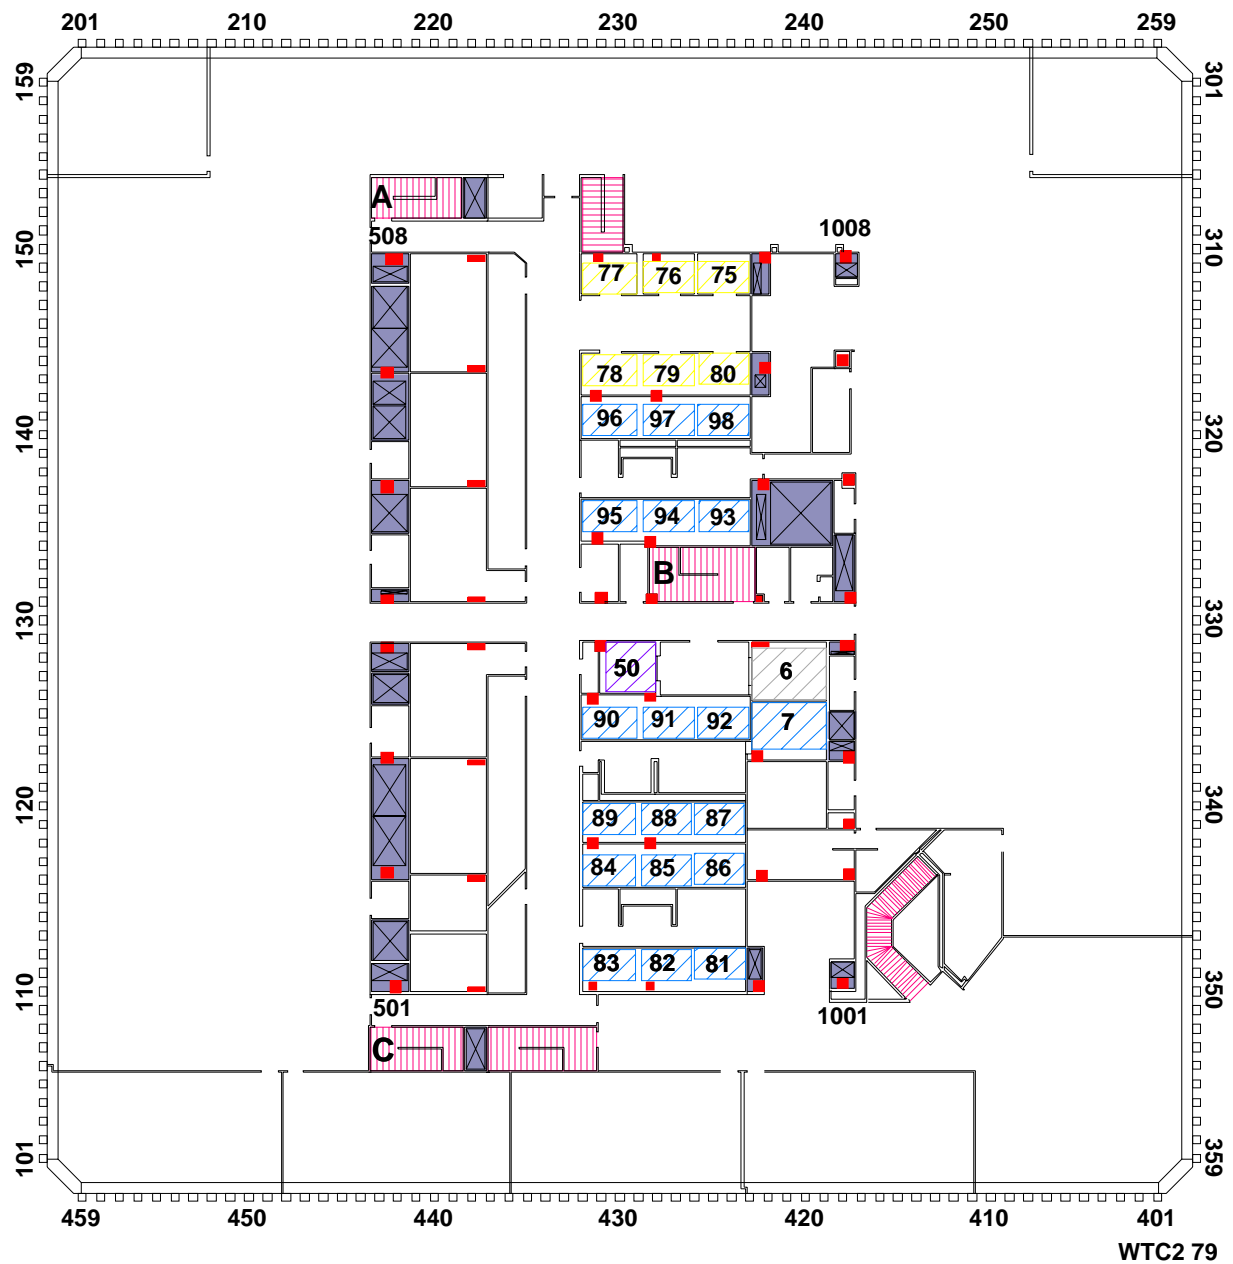
Figure B-11. This drawing shows the floor plan layout for the 79th floor of WTC 2.

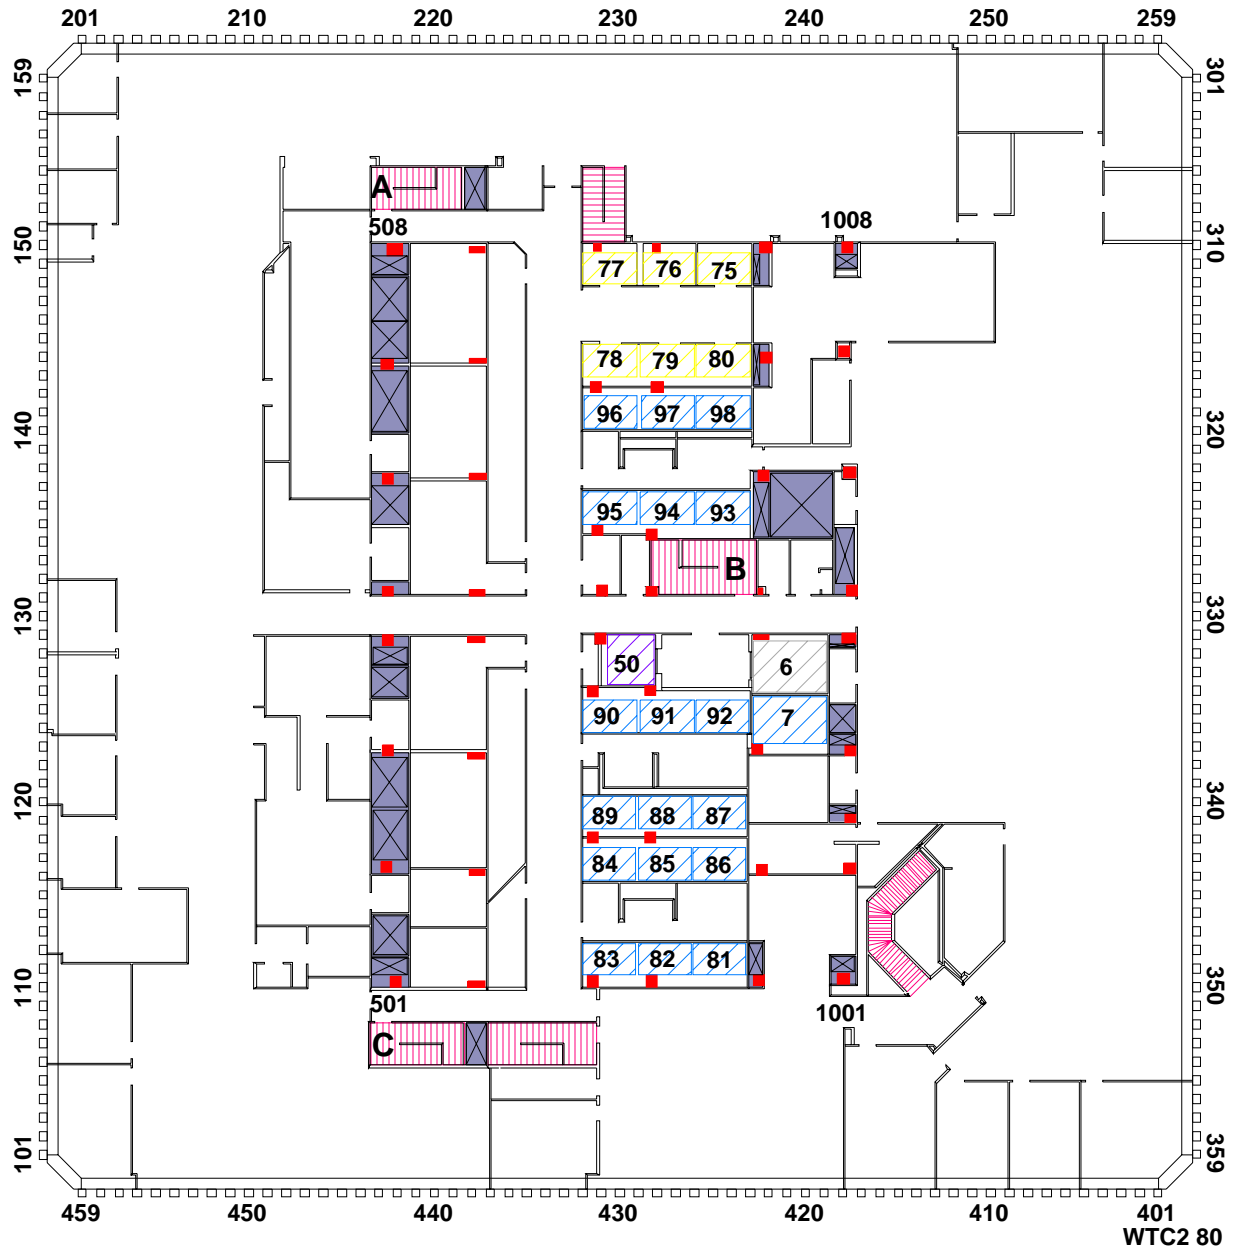
Figure B-12. This drawing shows the floor plan layout for the 80th floor of WTC 2.

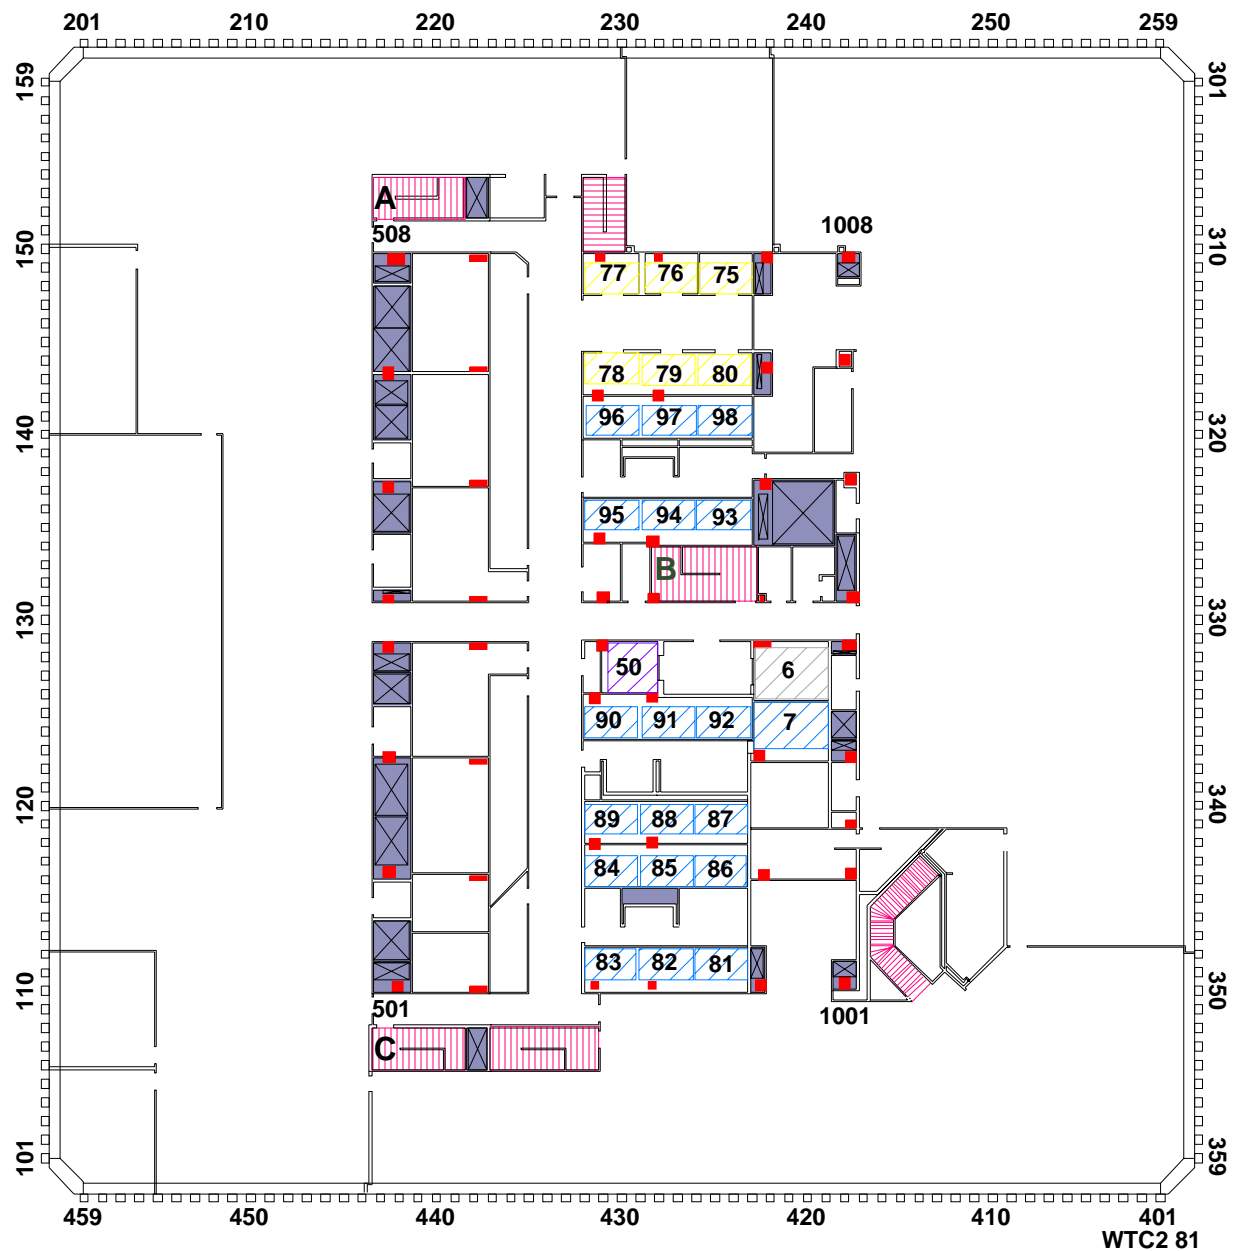
Figure B-13. This drawing shows the floor plan layout for the 81st floor of WTC 2.

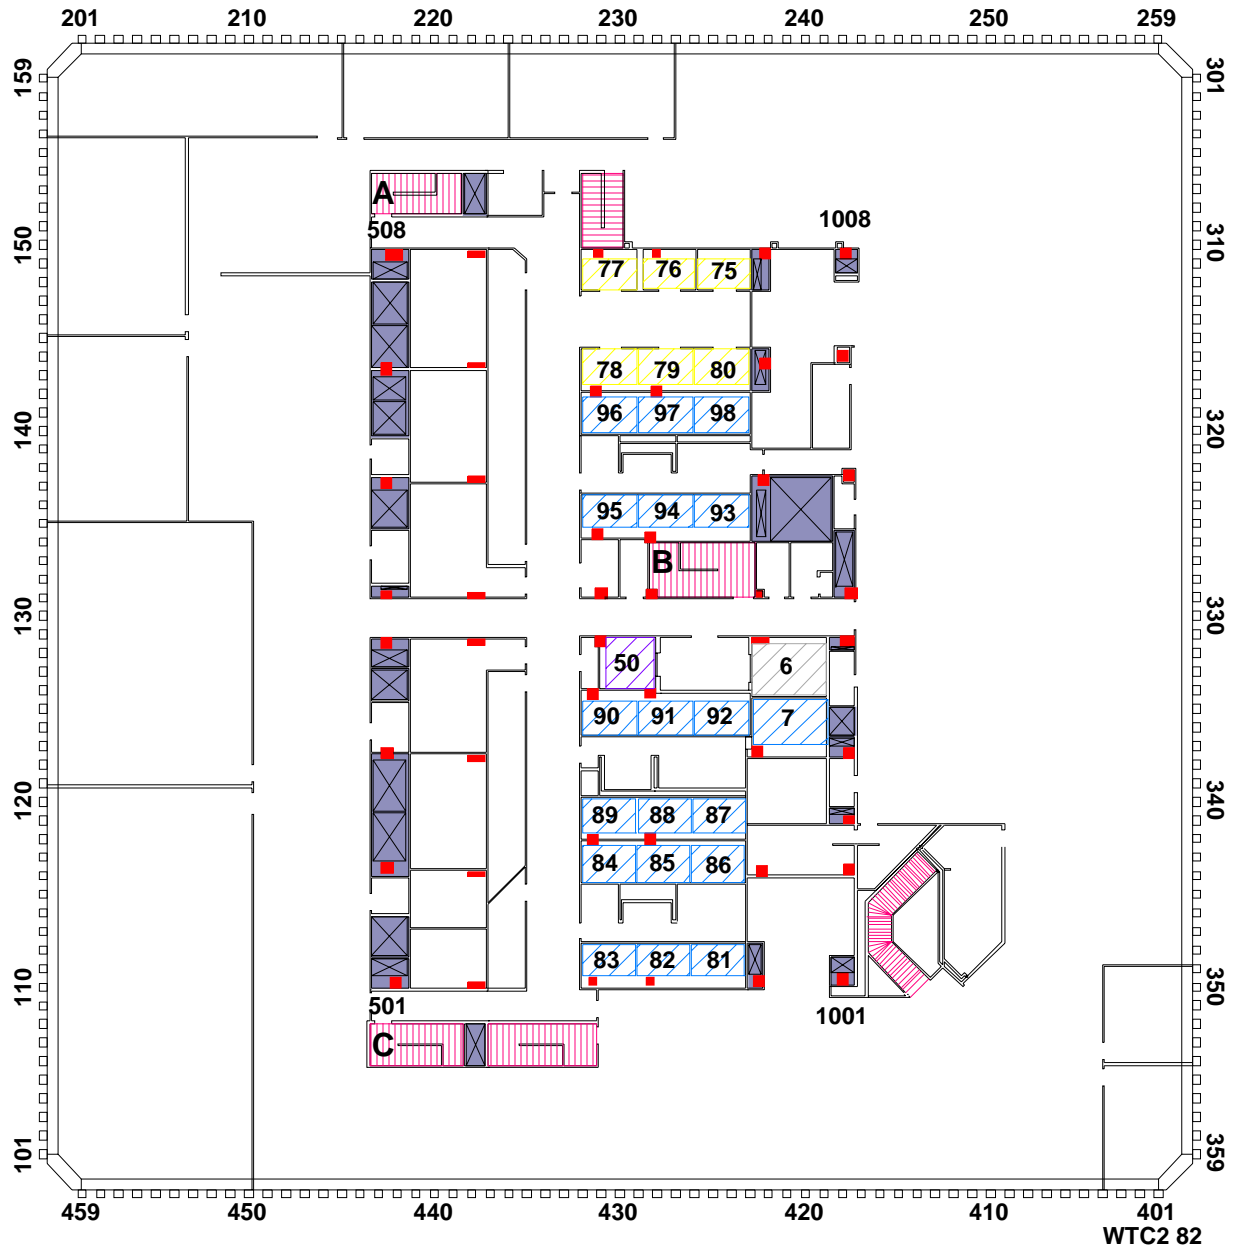
Figure B-14. This drawing shows the floor plan layout for the 82nd floor of WTC 2.

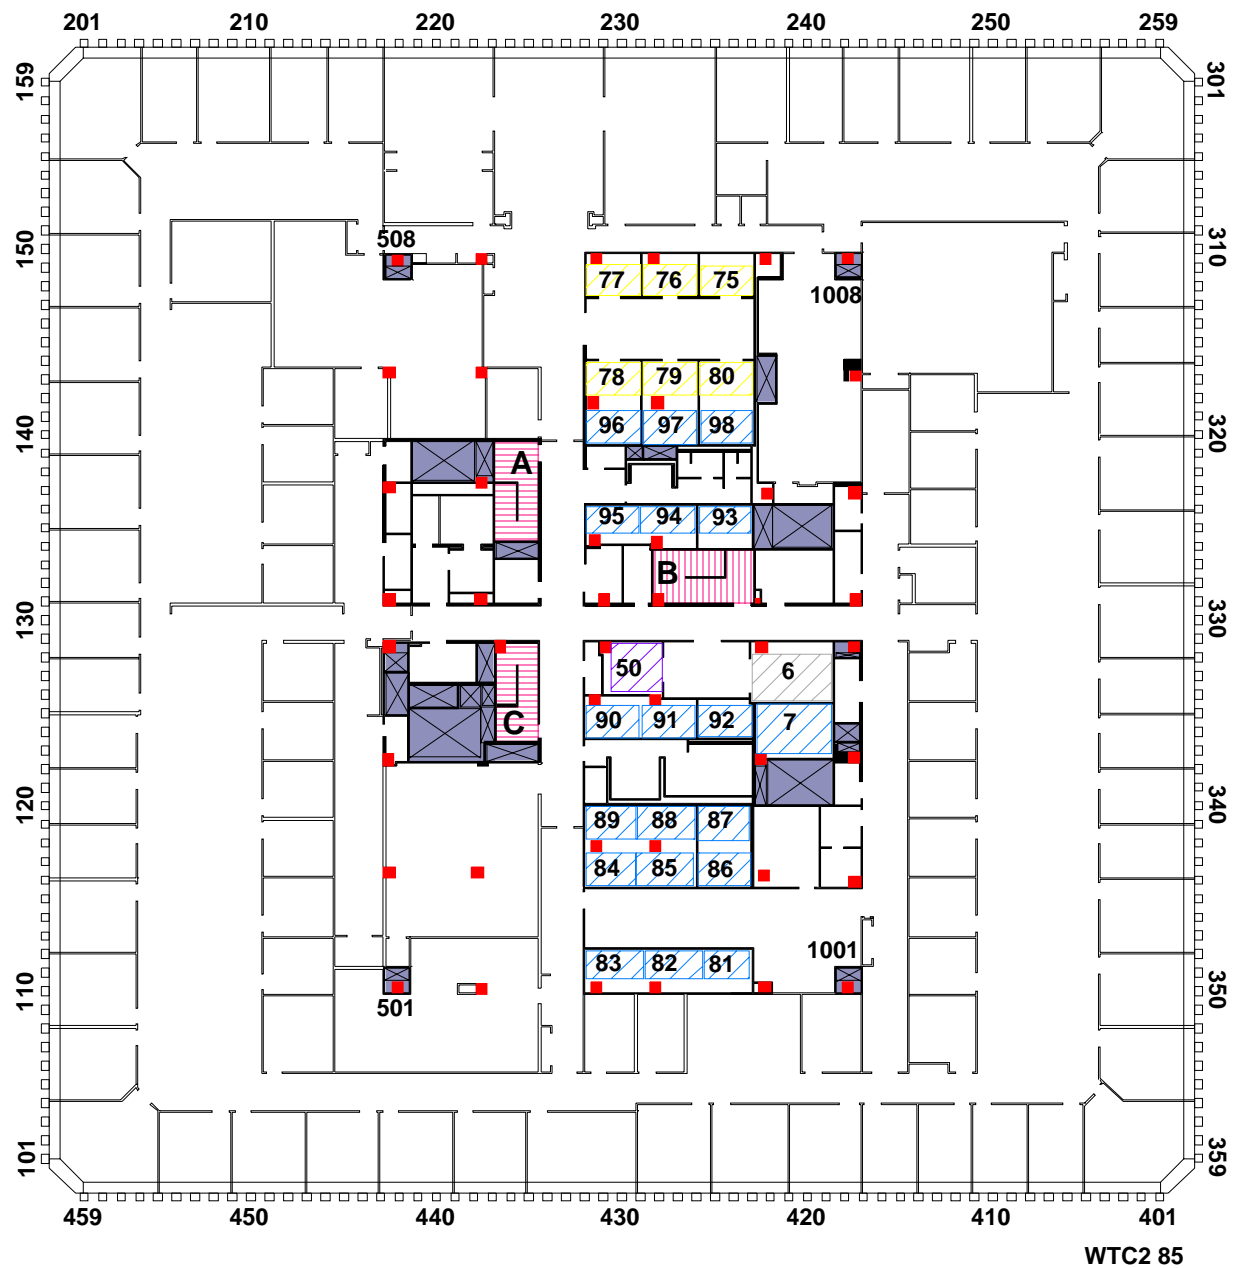
Figure B-15. This drawing shows the floor plan layout for the 85th floor of WTC 2.

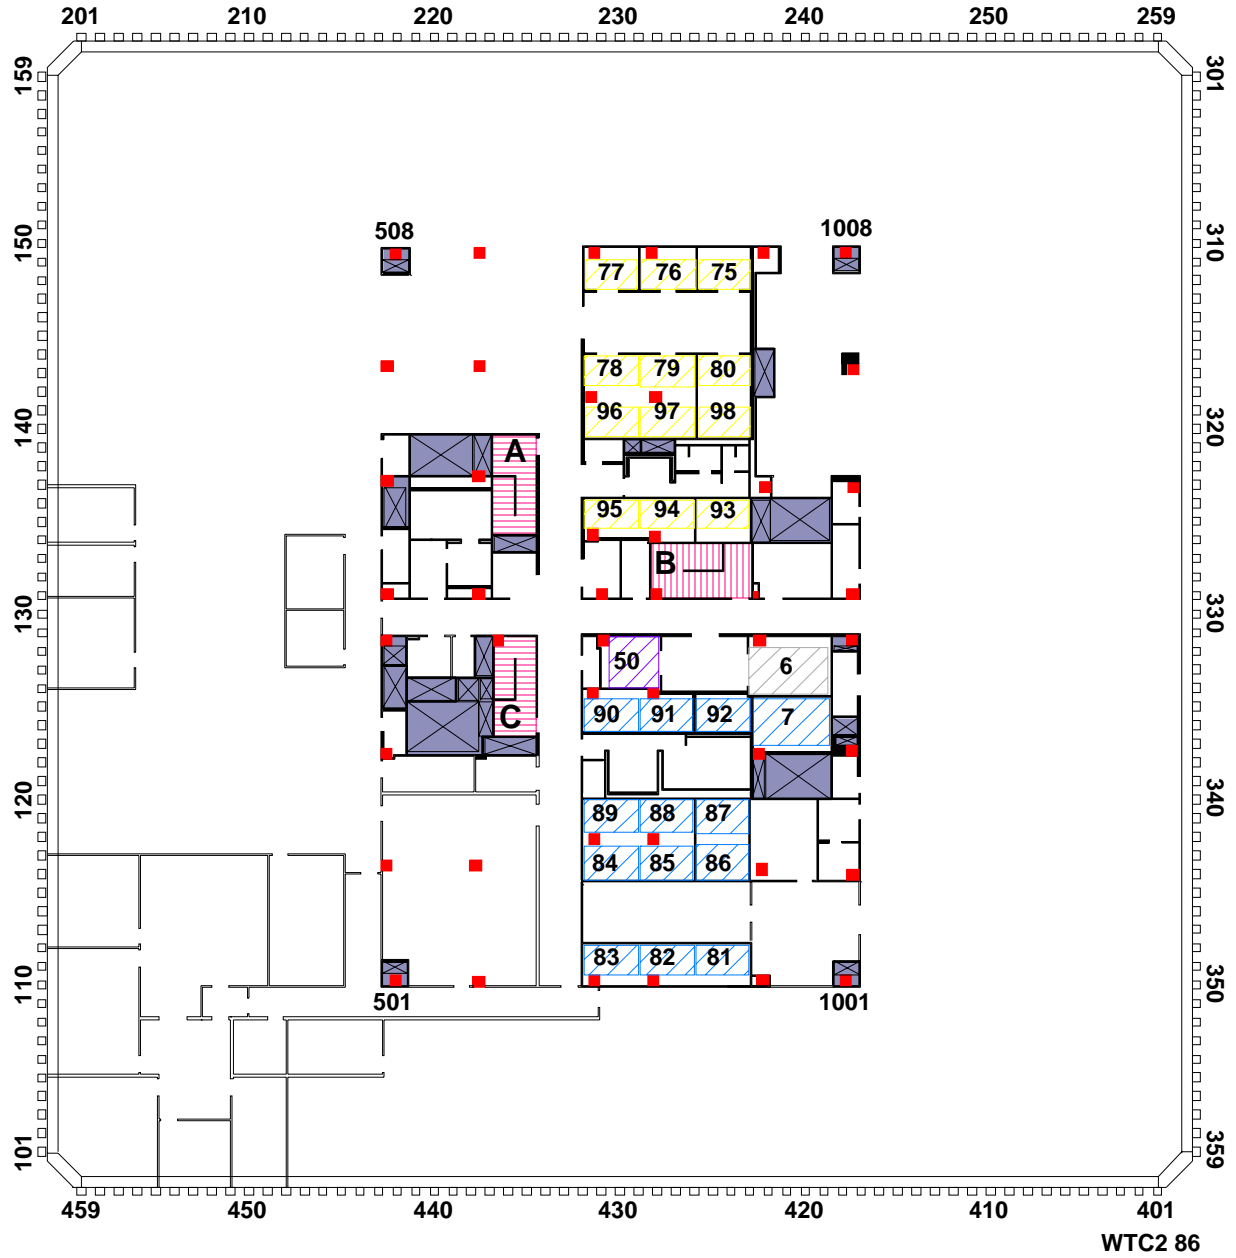
Figure B-16. This drawing shows the floor plan layout for the 86th floor of WTC 2.

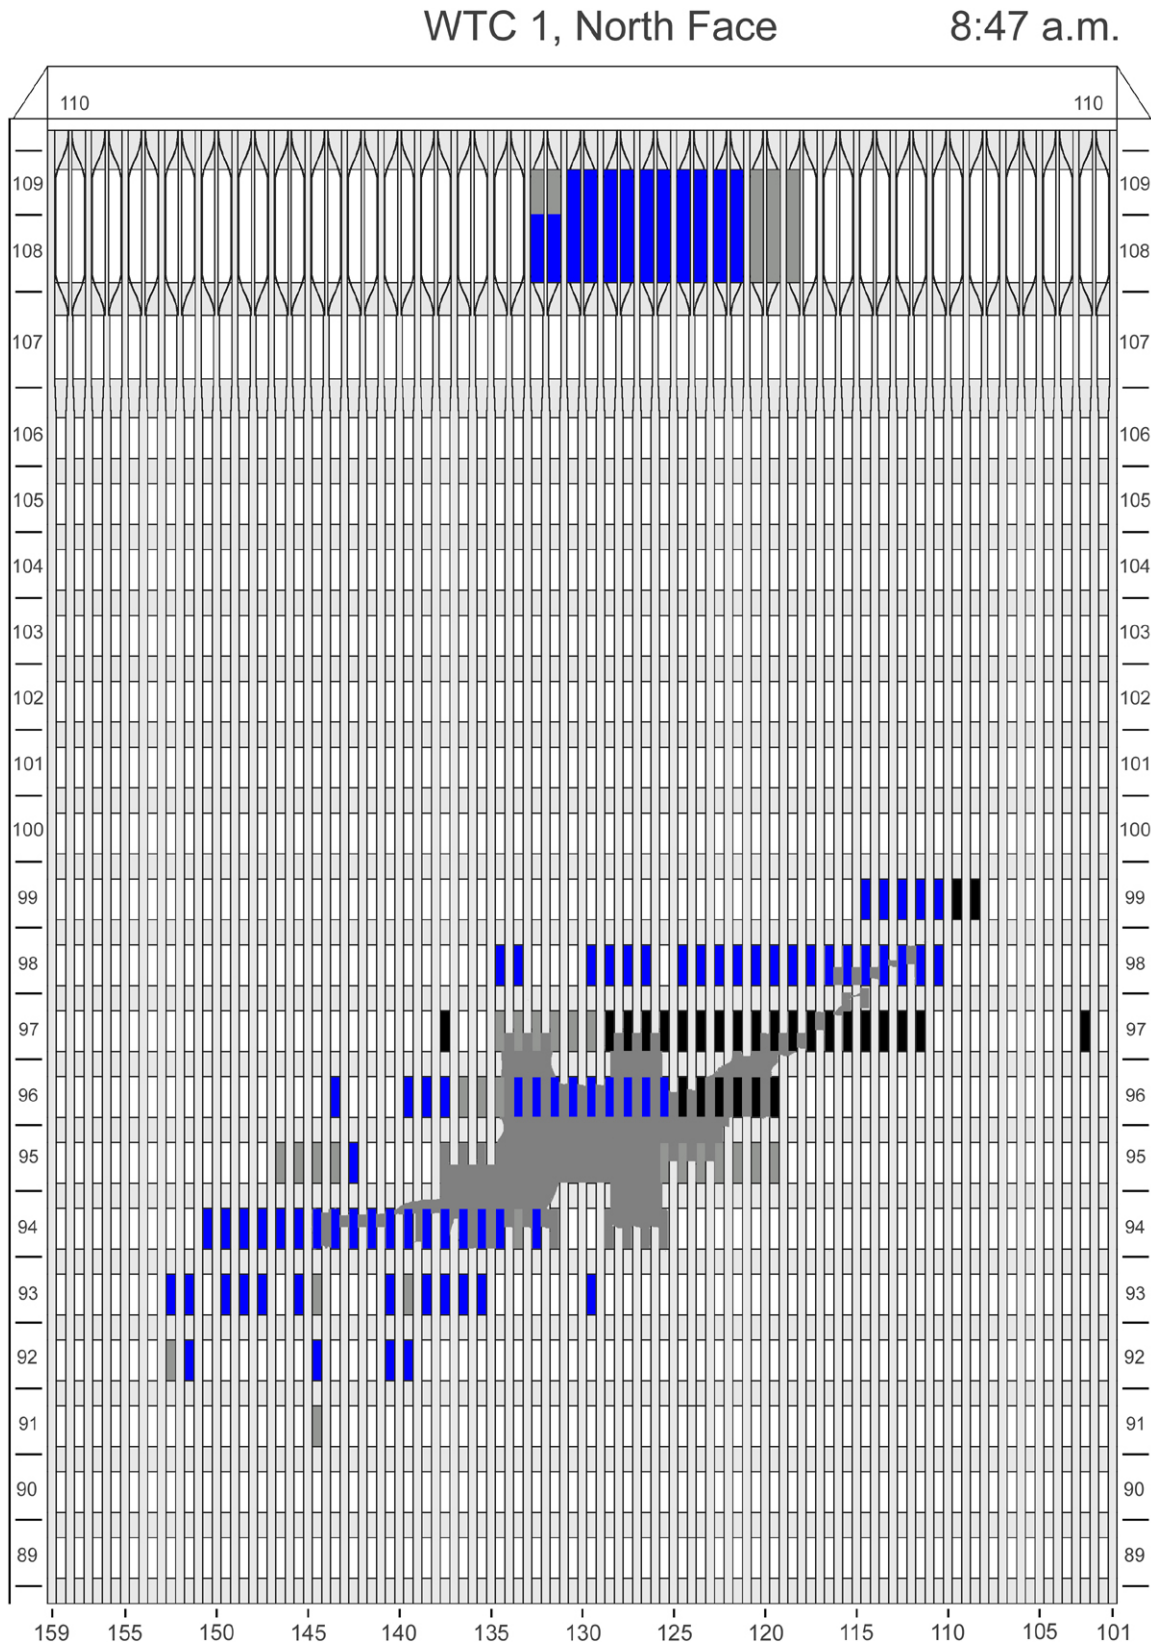
**Figure C-2. Diagram of the north face of WTC 1 for floors 89 to 110 at 8:47 a.m. showing windows where smoke was observed and those that were hidden from view.**

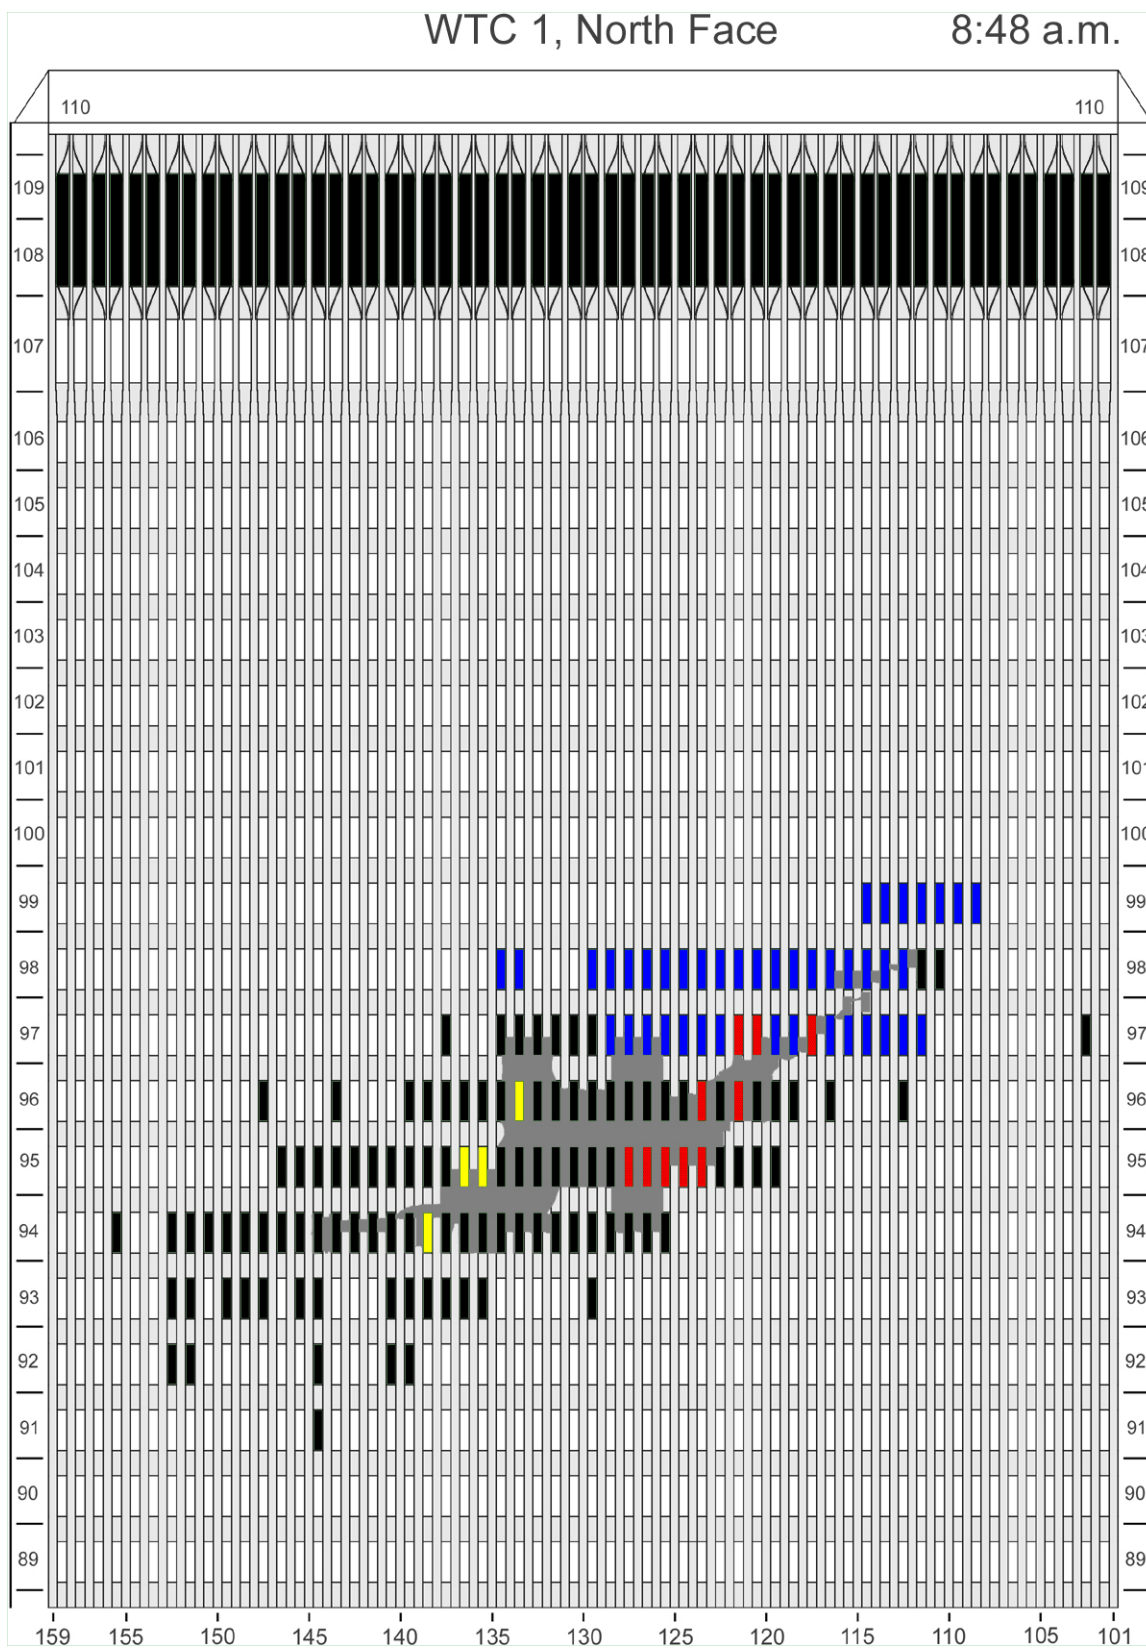
**Figure C-3. Diagram of the north face of WTC 1 for floors 89 to 110 at 8:48 a.m. showing the condition of windows and locations of fires.**

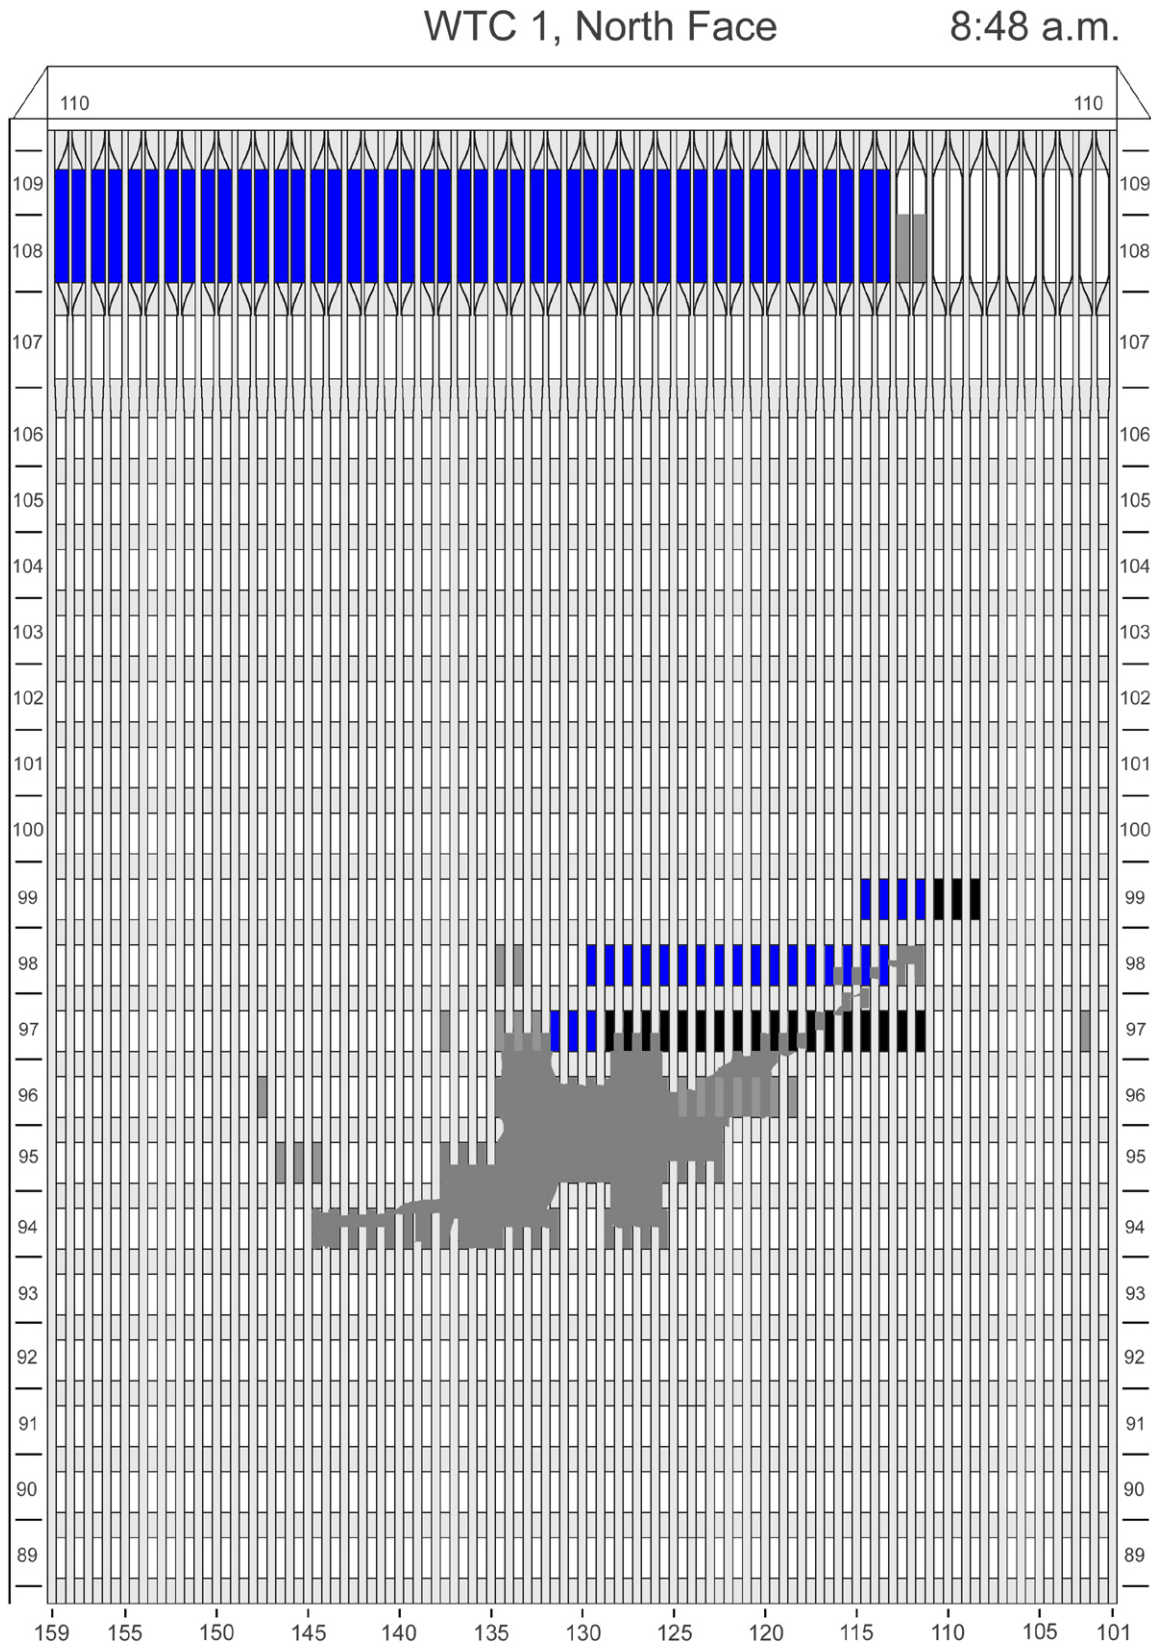
**Figure C-4. Diagram of the north face of WTC 1 for floors 89 to 110 at 8:48 a.m. showing windows where smoke was observed and those that were hidden from view.**
